# Unusual Geotechnical Solutions at the Leixões Cruise Terminal

A. Pinto, X. Pita & M. Neves

**ABSTRACT:** The aim of this paper is to present the main design and execution criteria related with both cofferdam and foundations solutions, using soil-cement panels, micropiles and bored piles in several applications, at the new Leixões Cruise Terminal, located at the Leixões Port, in Portugal. The Terminal building is being built with one basement on a marine environment, over very difficult geological and geotechnical conditions, which demanded the use of some unusual and integrated geotechnical solutions.

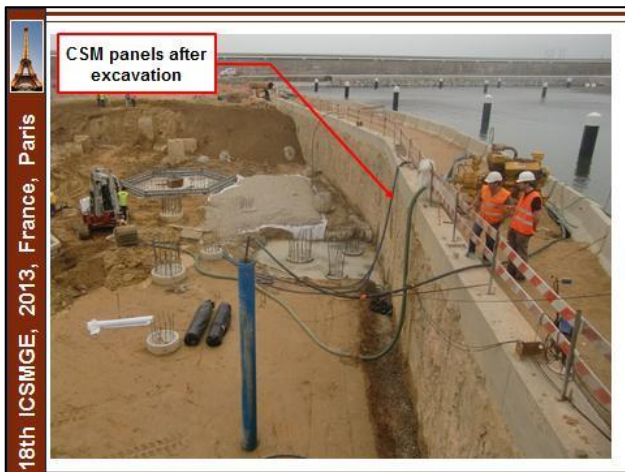
Figure 11. Solution T1 – view of soil-cement panels after excavation.

The soil - cement panels, with UCS resistance not lesser than 4MPa, were reinforced with vertical IPE330 steel profiles (Euronorm 19-57), spaced 0,55m in average, in order to resist to the earth and water pressures, as well as to ensure a better control of the deformations. The steel profiles were placed inside the panels, before the cement started the curing process and capped by a reinforced concrete beam (Figure 8 to 11).

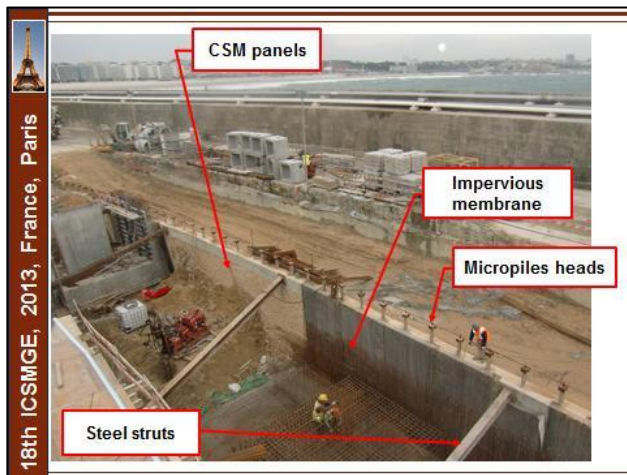
Figure 15. Solution T2 – soil - cement panels after excavation.

**Solution type 2 (T2):** soil - cement panels with a cross section of 2,4 x 0,5m<sup>2</sup>, including 0,20m of overlapping on a height of approximately 6.5m, correspondent to the previous excavation depth, performed in order to replace the break water rip rap by a sandy fill. The panels were built using the CSM technology. Below the soil - cement panels the cofferdam cut off effect was assured through a curtain, performed using alternated slurry cement injections through steel tubes and micropiles N80  $\phi$ 114,3x12mm, those also with foundation purposes and sealed 4m on the bed rock (Figures 12 to 15).
