Deep excavation for the new Central Library of Lisbon

A. Pinto & A. Pereira

JetSJ Geotecnia, Lda., Portugal, www.jetsj.pt

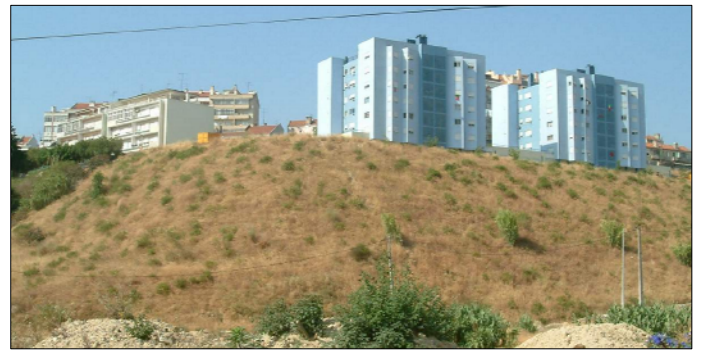
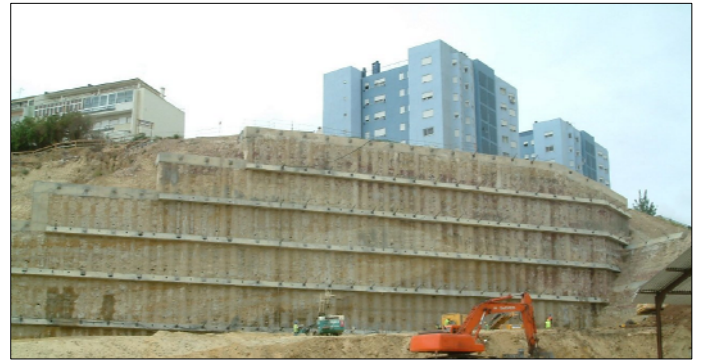
Figure 3. Site before excavation (a) and when the excavation depth was about 30 m (b).

Figure 3 shows a general view of the site before excavation (a) and when the excavation depth was about 30 m (b). In Figure 3b the solutions adopted for the two main sides can be seen; they will be described in section 3.

Solution 1 was used in the South-West side (Figure 4), where the maximum excavation depth is 40 m (including 20 m of fills). This solution corresponds to the main wall, which can be seen in Figure 3b). Where the excavation depth was greater than 36 m, the bored piles were 1 m of diameter, spaced 1.3 m between axes; for excavation depths less than 36 m, they were 0.8 m diameter and spaced 1.5 m. The stability of the wall was ensured by 10 levels of permanent anchors, sealed in the soil mass at ZG1. Its horizontal spacing is 2.6 m (excavation depth over 36 m) and 3.0 m (remaining area). Jet-grouting columns were performed between the piles in the depth of ZG2 and ZG3. In ZG1, shotcrete was used to protect the soil between the piles. Maintenance and anchor monitoring will be possible due to the distance of 3.0 m between the wall and the building structure, as shown in Figure 4.

Solution 2 was used in the North-East side (Figure 5). It can be seen in the right part of Figure 3b and in Figure 6. Piles are 0.8 m of diameter and the spacing between axes is 1.5 m. Temporary anchors were used to stabilize the wall. This pile wall was used below floor 0. Above floor 0 (ZG3) a slope stabilization solution using jet-grouting columns installed before excavation was used. Top concrete beams and temporary anchors were designed and performed.

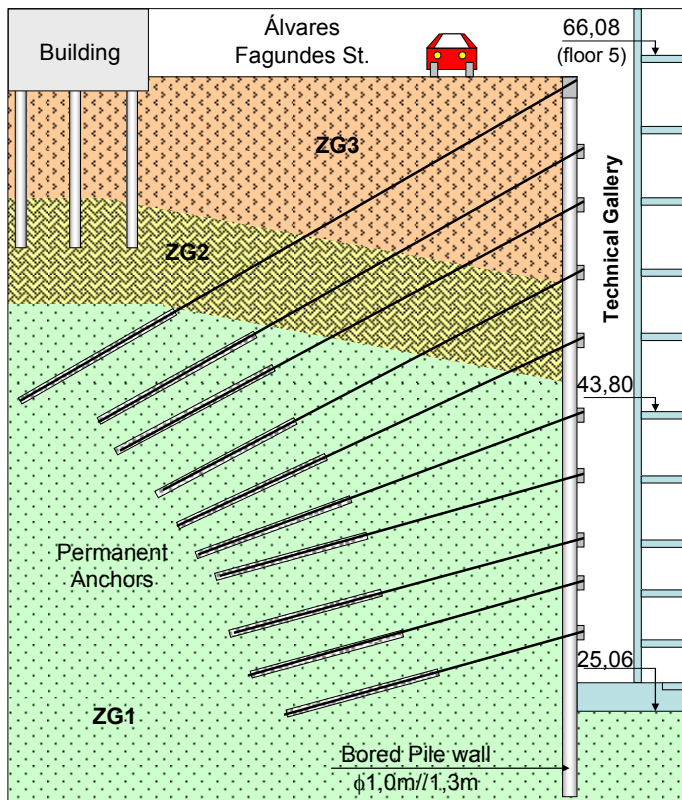
Figure 4. Cross section of the South-West side (solution 1).

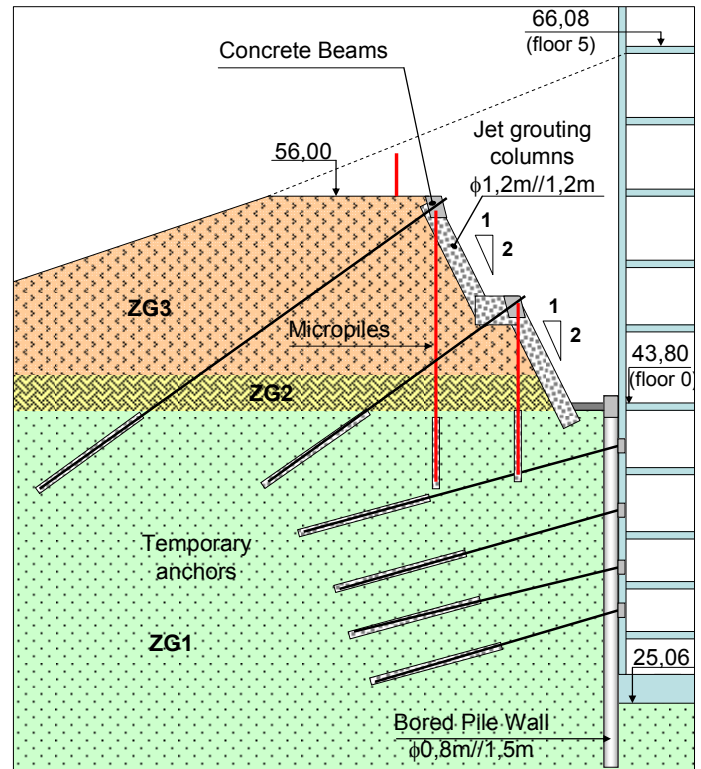
Figure 5. Cross section of the North-East side (solution 2).

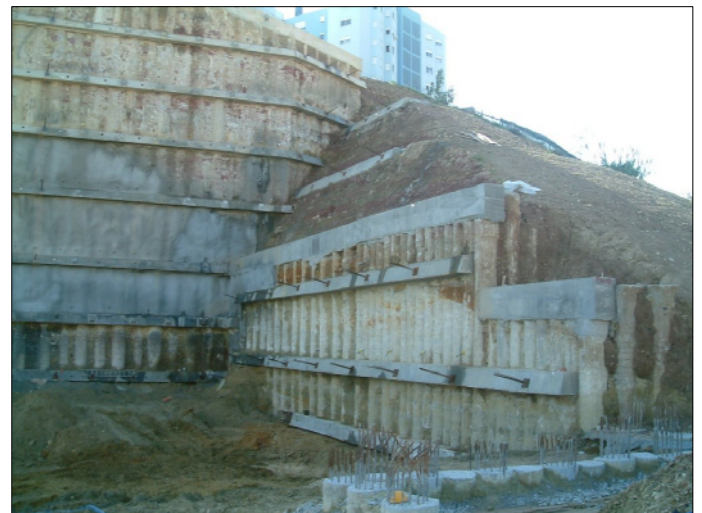
Figure 6. Excavation on the North-East side (solution 2).

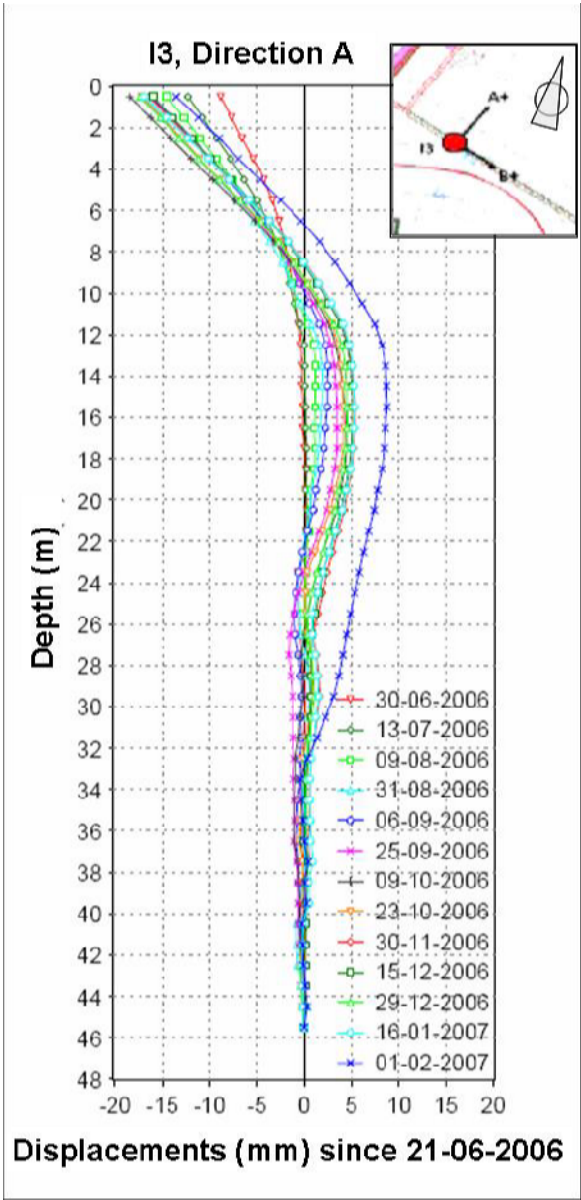
An example of the displacements of the retaining wall is presented in Figure 10. In this figure, results of the displacements of inclinometer 3 (located in the South-West wall) in the direction normal to the wall are shown. Positive displacements are those occurring towards the excavation. Displacements are

Figure 10. Results of the displacements in the direction normal to the excavation wall obtained from inclinometer I3.

Considering the overall depth of the excavation and the mechanical characteristics of the supported soils, the obtained displacements (which are confirmed by other inclinometers) are small ($\Delta h/H = 0.009/33 \approx 0.03\%$) and in general lesser than the design prediction.

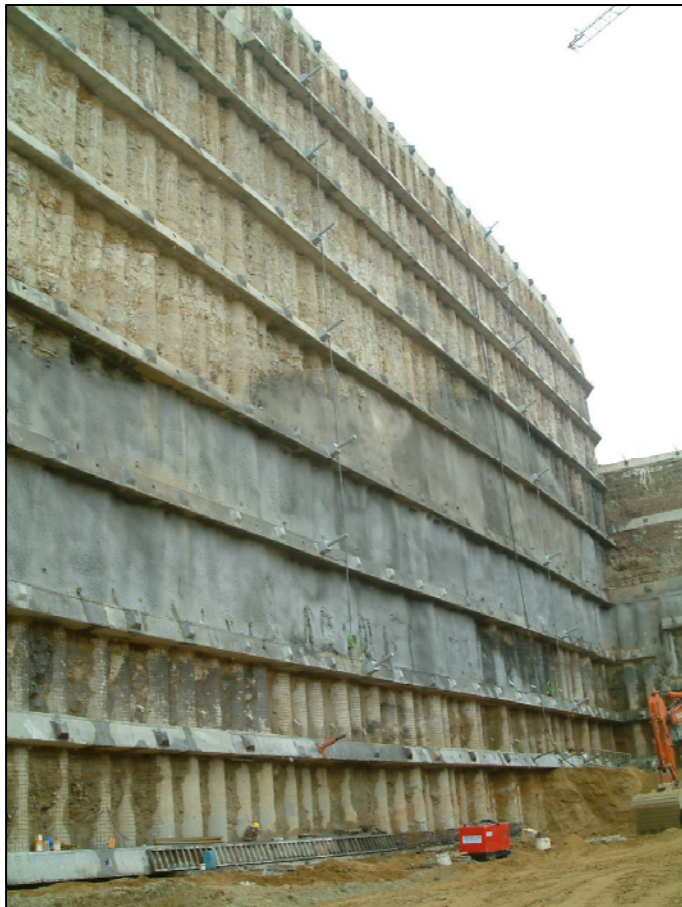
Figure 11. View of the permanent ground anchors with two sections with load cells at the South – West wall

All the ground anchors were tested previously to lock off according to the EN 1537, acceptance tests and suitability tests were performed, the last ones on anchors with load cells. All the anchors were also pre-grouted before the installation inside the bore-holes (see figures 11 and 12).

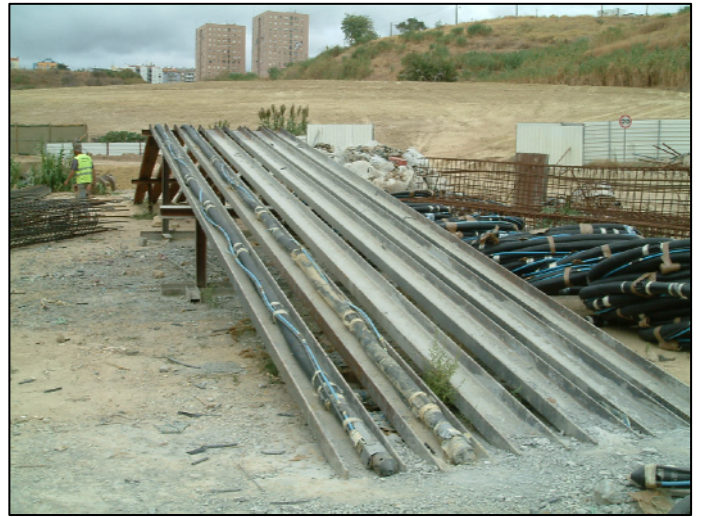
Figure 12. View of the permanent ground anchors pre-grouting
